DEPARTMENT OF TRANSPORTATION

Contract #: 04-0120F4Cty: SF/ALA Rte: 80 PM: 13.2/13.9File #: 69.28**WELDING INSPECTION REPORT****Resident Engineer:**Pursell, Gary**Address:** 333 Burma Road**City:** Oakland, CA 94607**Report No:** WIR-003163**Date Inspected:** 29-Jun-2008**Project Name:** SAS Superstructure**OSM Arrival Time:** 630**Prime Contractor:** American Bridge/Fluor Enterprises, a JV**OSM Departure Time:** 1530**Contractor:** Zhenhua Port Machinery Company, Ltd (ZPMC), Changxing Island **Location:** Shanghai, China

WELDING INSPECTION REPORT

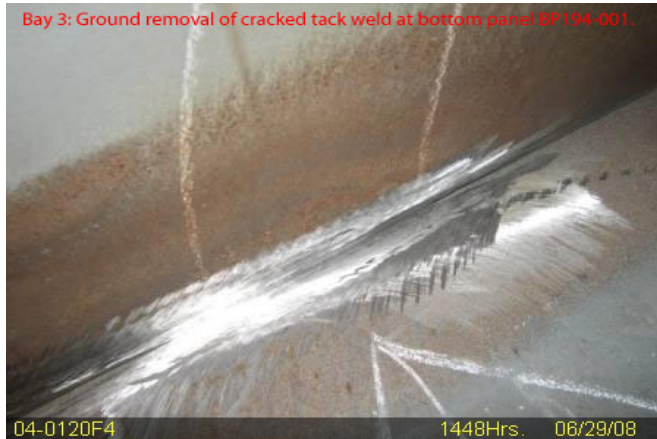
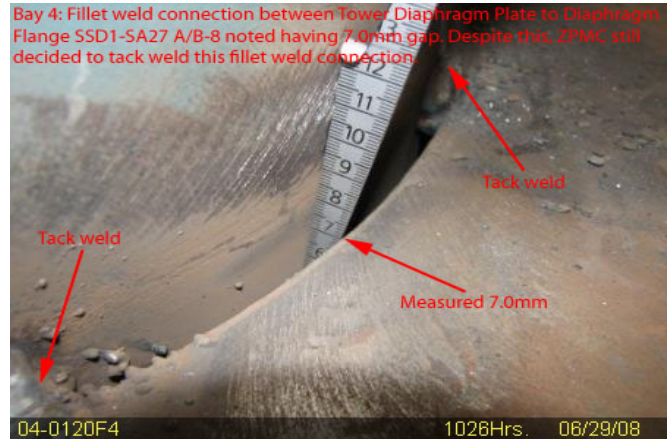
This QA was called by one of the ABF QA Inspector to confirm the existence of 11 cracked tack welds on

6-WT(W21x57) rib stiffener to bottom panel BP194-001. Although one of the 11 suspected cracked tack welds is obvious, there was a need to confirm the rest with better method and that is Magnetic Particle Testing. ZPMC QC called for NDE to conduct MT on these suspected tack welds but there was no available at that time. ZPMC personnel decided to grind/remove said tack welds and then do the MT after their removal. This QA randomly observed the ground/removal of all 11 tack welds and MT thereafter. See photo below.

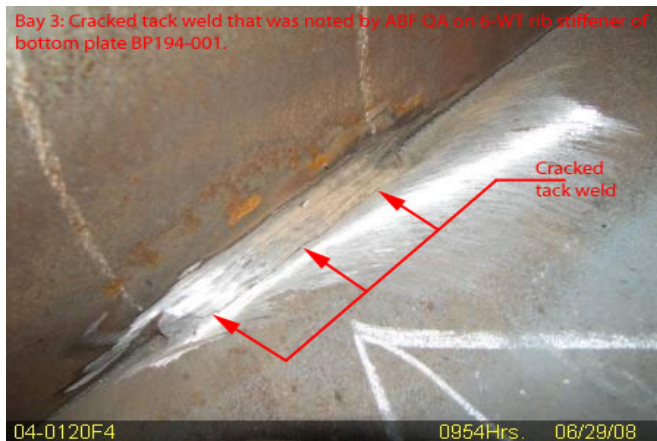
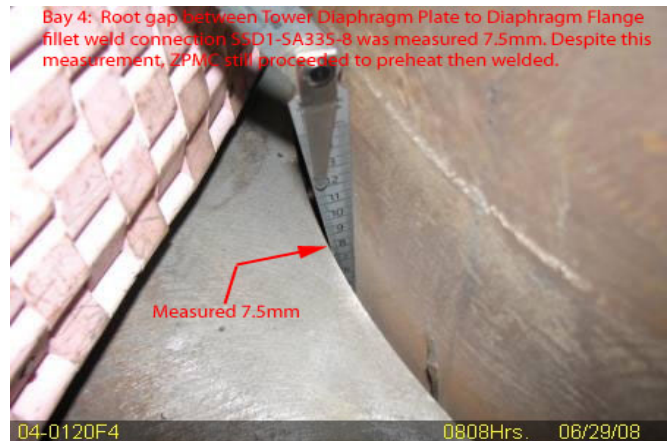
This QA observed preheating of fillet weld connection between tower diaphragm plates to diaphragm flange SSD1-SA335-8 using corner thermal blanket despite noted gap of 7.5mm on one corner of the connection. Later during the day when preheat was already up to temperature, two ZPMC welders have started fillet welding. Also on another tower diaphragm plate to diaphragm flange fillet connection SSD1-SA27 A/B-8, tack welding started despite 7.0mm gap noted. ABF QA Inspector Man Kam Hon informed this QA that he is recording the gaps between the flange and plate on the above mentioned fillet weld connection and that ZPMC might ask for a revision on the working WPS for this. See photo below.
